**January 11, 2019**

Version 2

**2017-18 CR-V: Software Update with A/C Control Unit Replacement;  
DTC P0300, P0301, P0302, P0303, P0304, or P0172**Supersedes 18-147, dated December 19, 2018, to revise the information highlighted in **yellow****REVISION SUMMARY**

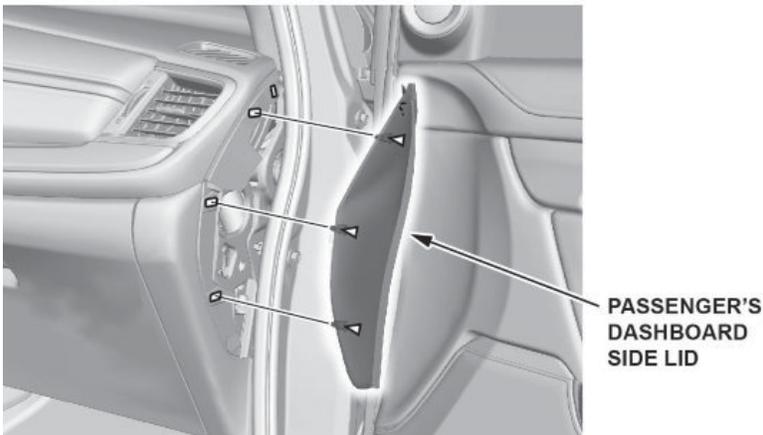
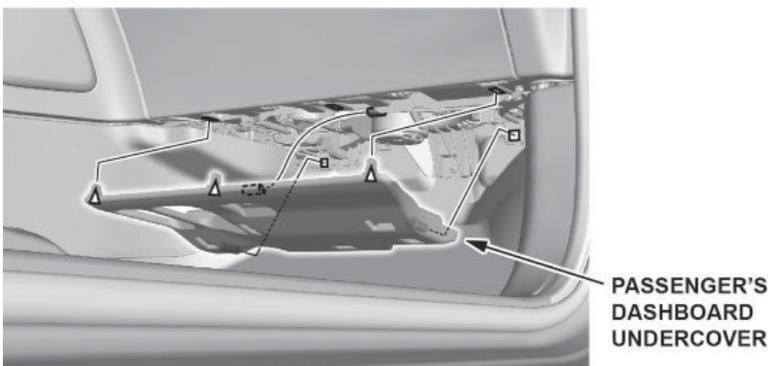
1. Reset the maintenance minder.
2. Drain and refill the engine oil. Do not replace the oil filter.
3. Connect the i-HDS and click on the **Body Electrical**. From there, select **HVAC** and open **Data List/Snapshot** to check if the A/C control unit has been replaced. One of three options will appear; **Not Complete**, **Completed**, or **Not Applicable**.
  - If it reads **Completed** or **Not Applicable**, skip to step 5.
  - If it reads **Not Complete**, go to step 4.
4. Replace the A/C control unit.
  - 4.1. Remove the passenger's dashboard side lid and the dashboard undercover.

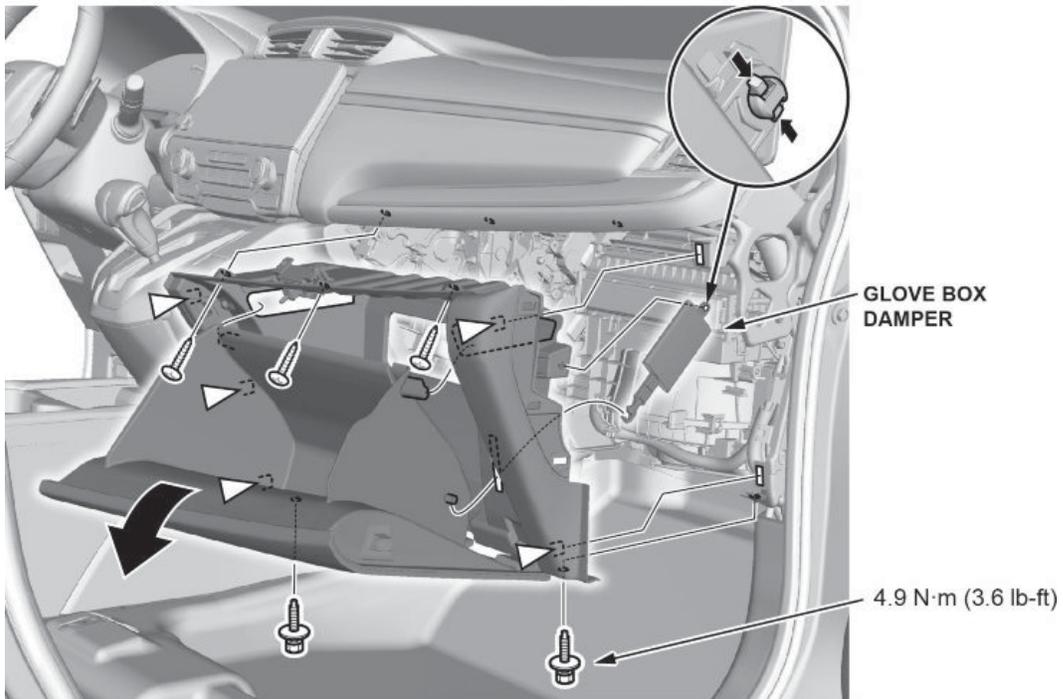
4.2. Remove the glove box.

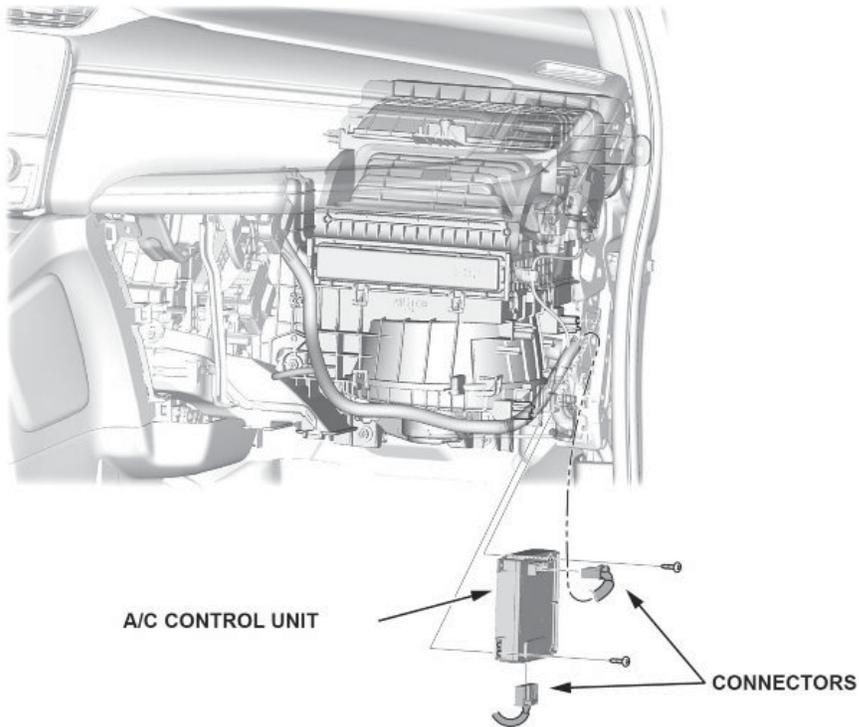
4.3. Remove the A/C control unit and replace with the new unit.

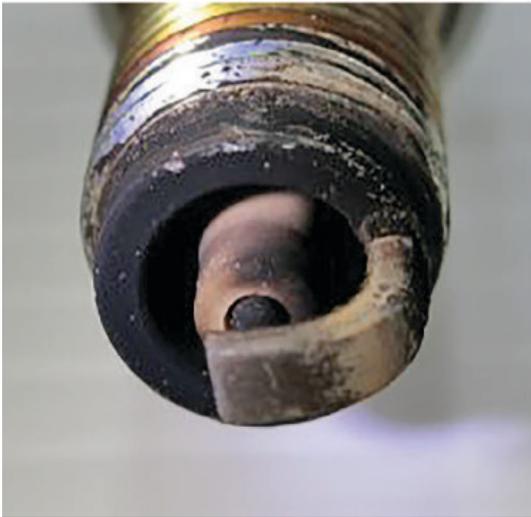
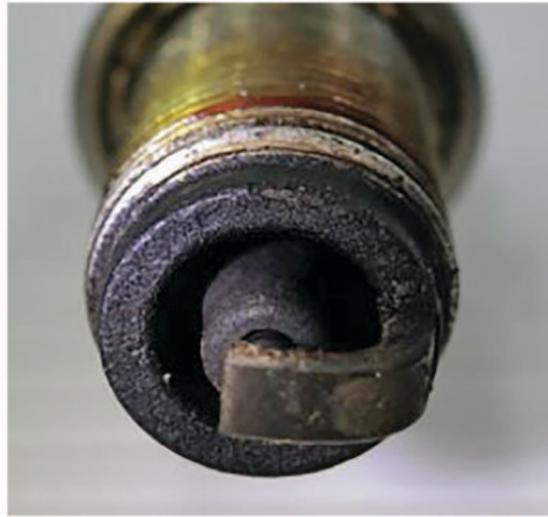
8. Inspect the spark plugs.

- If the spark plugs are OK, the procedure is complete. Continue with normal troubleshooting.
  - If the spark plugs are fouled, go to step 9.
9. Replace the spark plugs per service information and check for stored DTCs.
